**Axis at The Canyons**  
**Association #: 01.01.3175**

**Level 1 -- Full Reserve Study with Site Visit**

**Prepared By: Tyler Wood**

**Date of Site Inspection: 01/02/2025**

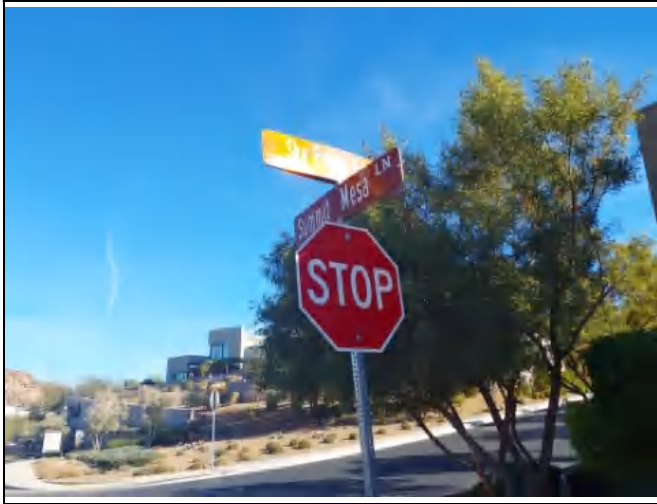
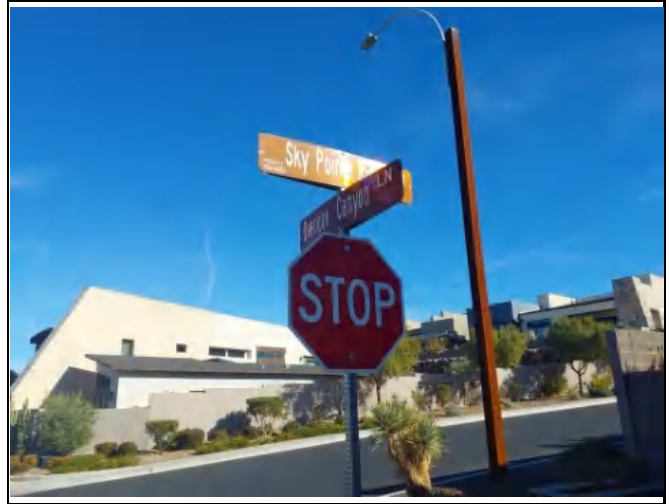
## Comp #: 1.139 Street Signs - Replace

| <b>General Notes:</b> | 9 Street Signs, 2 Misc. Signs - Sky Point Ridge Dr.<br>2 Street Signs, 2 Misc. Signs - Outlook Canyon Ln.<br>2 Street Signs, 2 Misc. Signs - Ledge Rock Ln.<br>5 Street Signs, 4 Misc. Signs - Summit Mesa Ln.<br>1 Street Sign - Skyline Heights Ln.<br><br>Total: 10 Street Signs, 10 Misc. Signs | | |

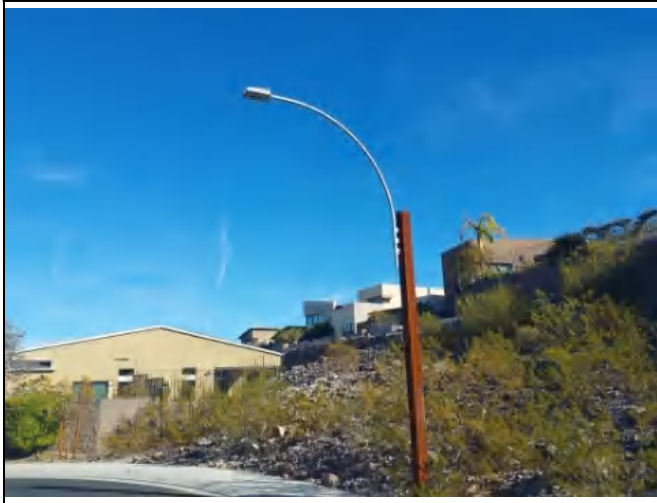
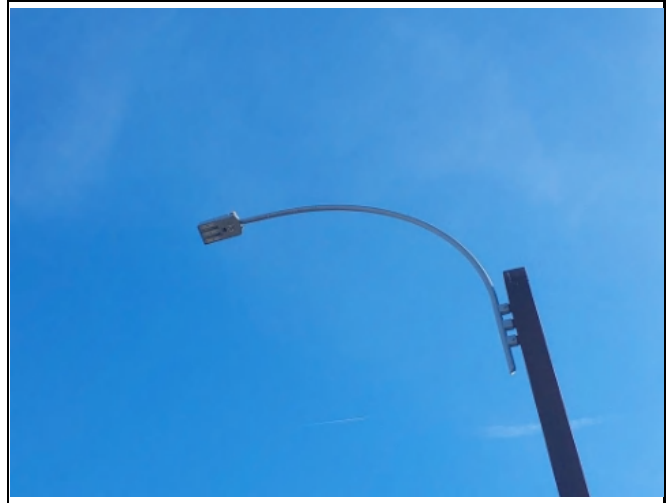
## Comp #: 1.201 Street Light Fixtures - Replace

| <b>General Notes:</b> | <p>7 Street Lights - Canyon Highlands Dr.<br/> 4 Street Lights - Sky Point Ridge Dr.<br/> 1 Street Light - Outlook Canyon Ln.<br/> 1 Street Light - Skyline Heights Ln.<br/> 1 Street Light - Ledge Rock Ln.<br/> 1 Street Light - Summit Mesa Ln.</p> | | |

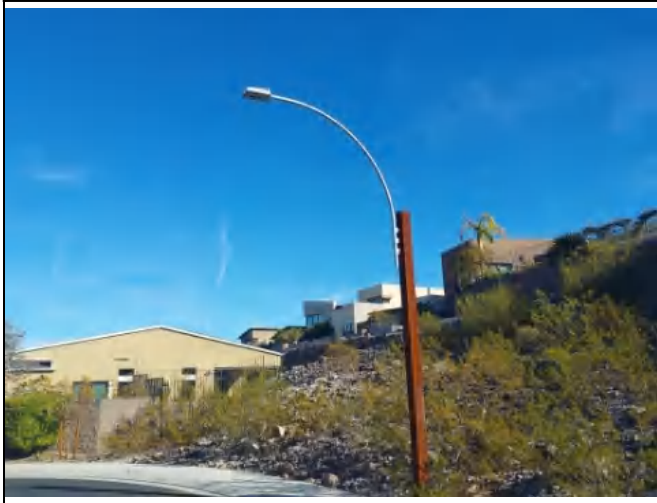
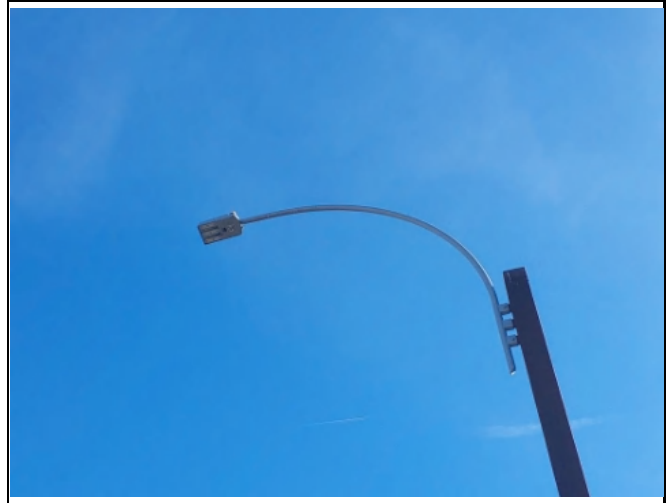
## Comp #: 1.203 Street Light Fixtures - Repair

| <b>General Notes:</b> | 7 Street Lights - Canyon Highlands Dr.<br>4 Street Lights - Sky Point Ridge Dr.<br>1 Street Light - Outlook Canyon Ln.<br>1 Street Light - Skyline Heights Ln.<br>1 Street Light - Ledge Rock Ln.<br>1 Street Light - Summit Mesa Ln. | | |

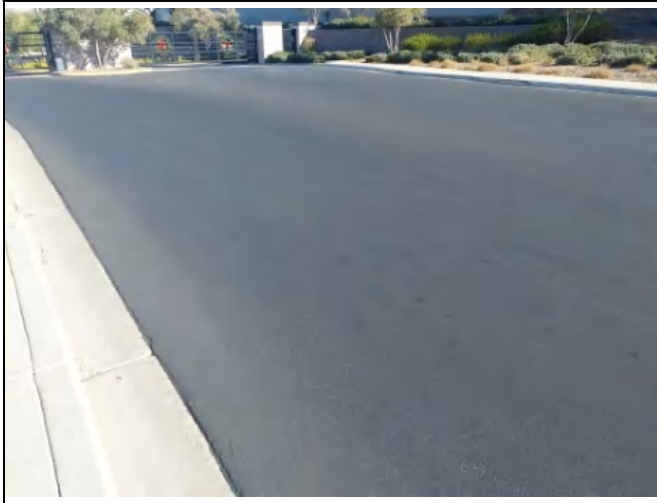
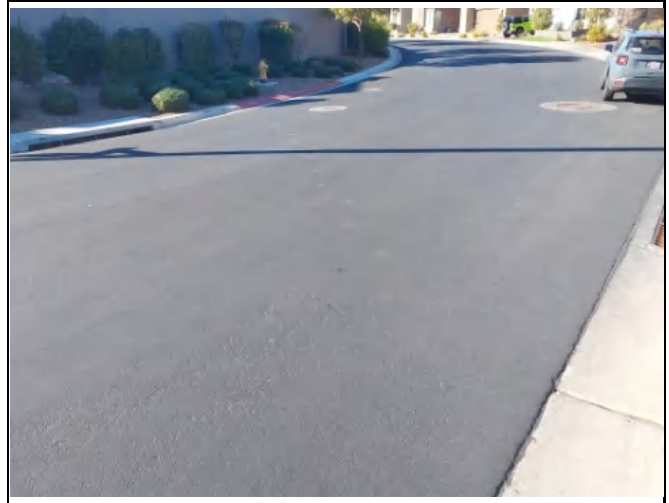
**Comp #: 1.301 Asphalt - Major Rehab**

| <b>Evaluation:</b> | No problems noted at time of site visit. | | |

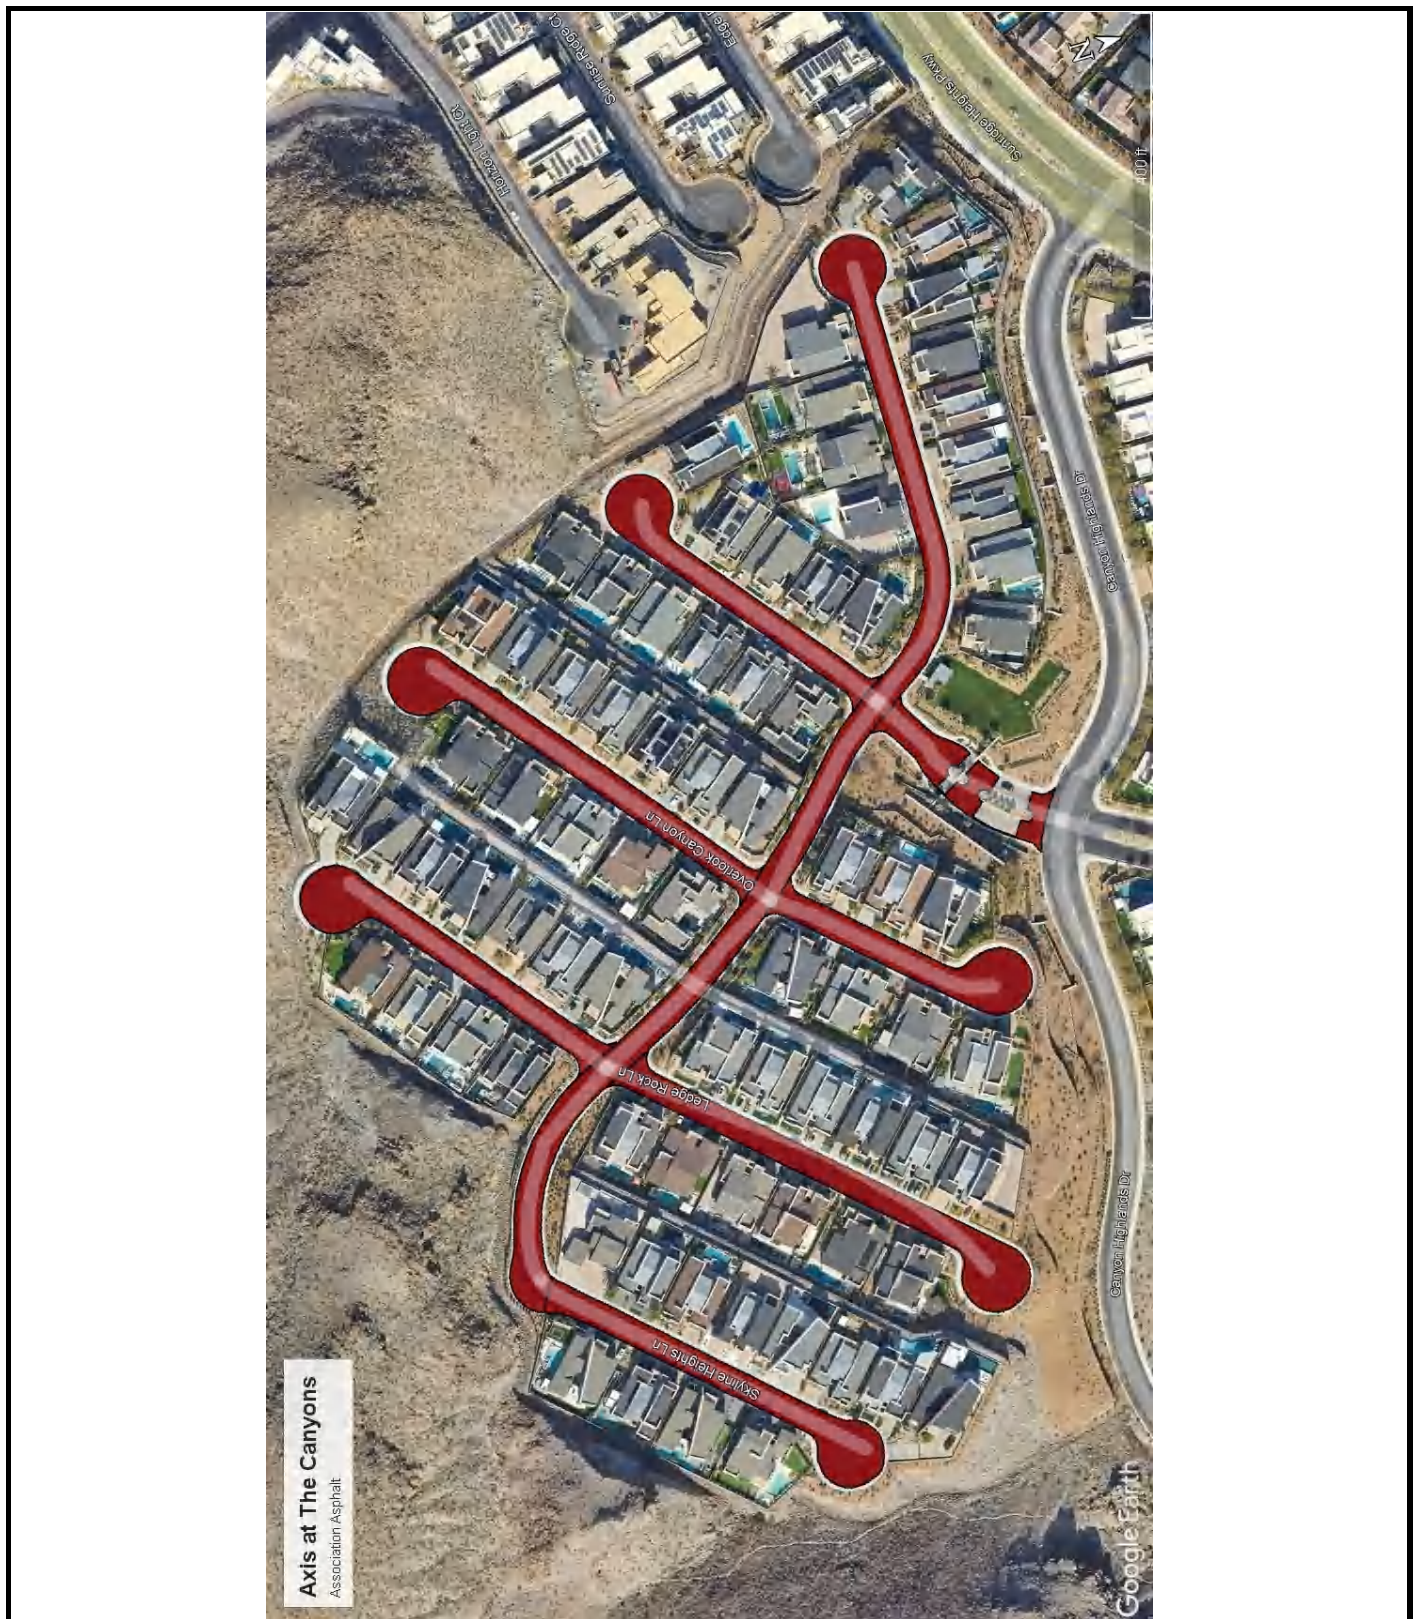
Association maintained asphalt

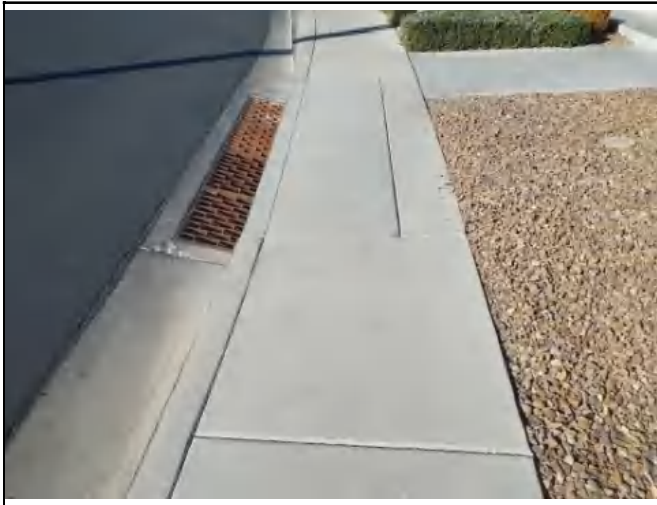
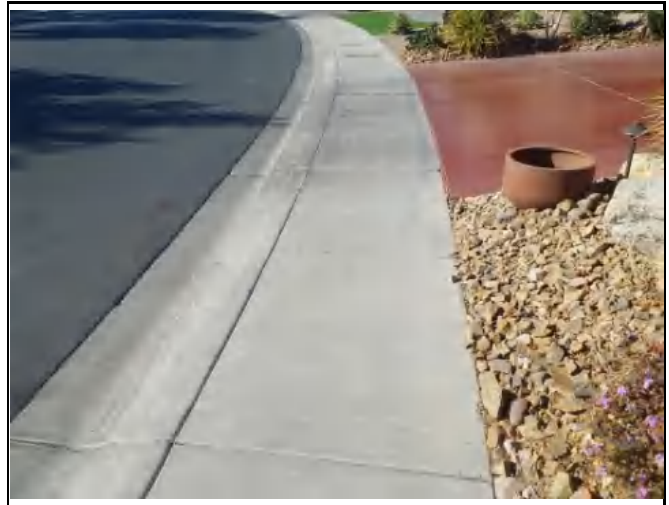
**Comp #: 1.402 Concrete - Repair**

| <b>Evaluation:</b> | No major spalling or delamination noted. We recommend inspecting and repairing any minor cracks or issues annually. | | |

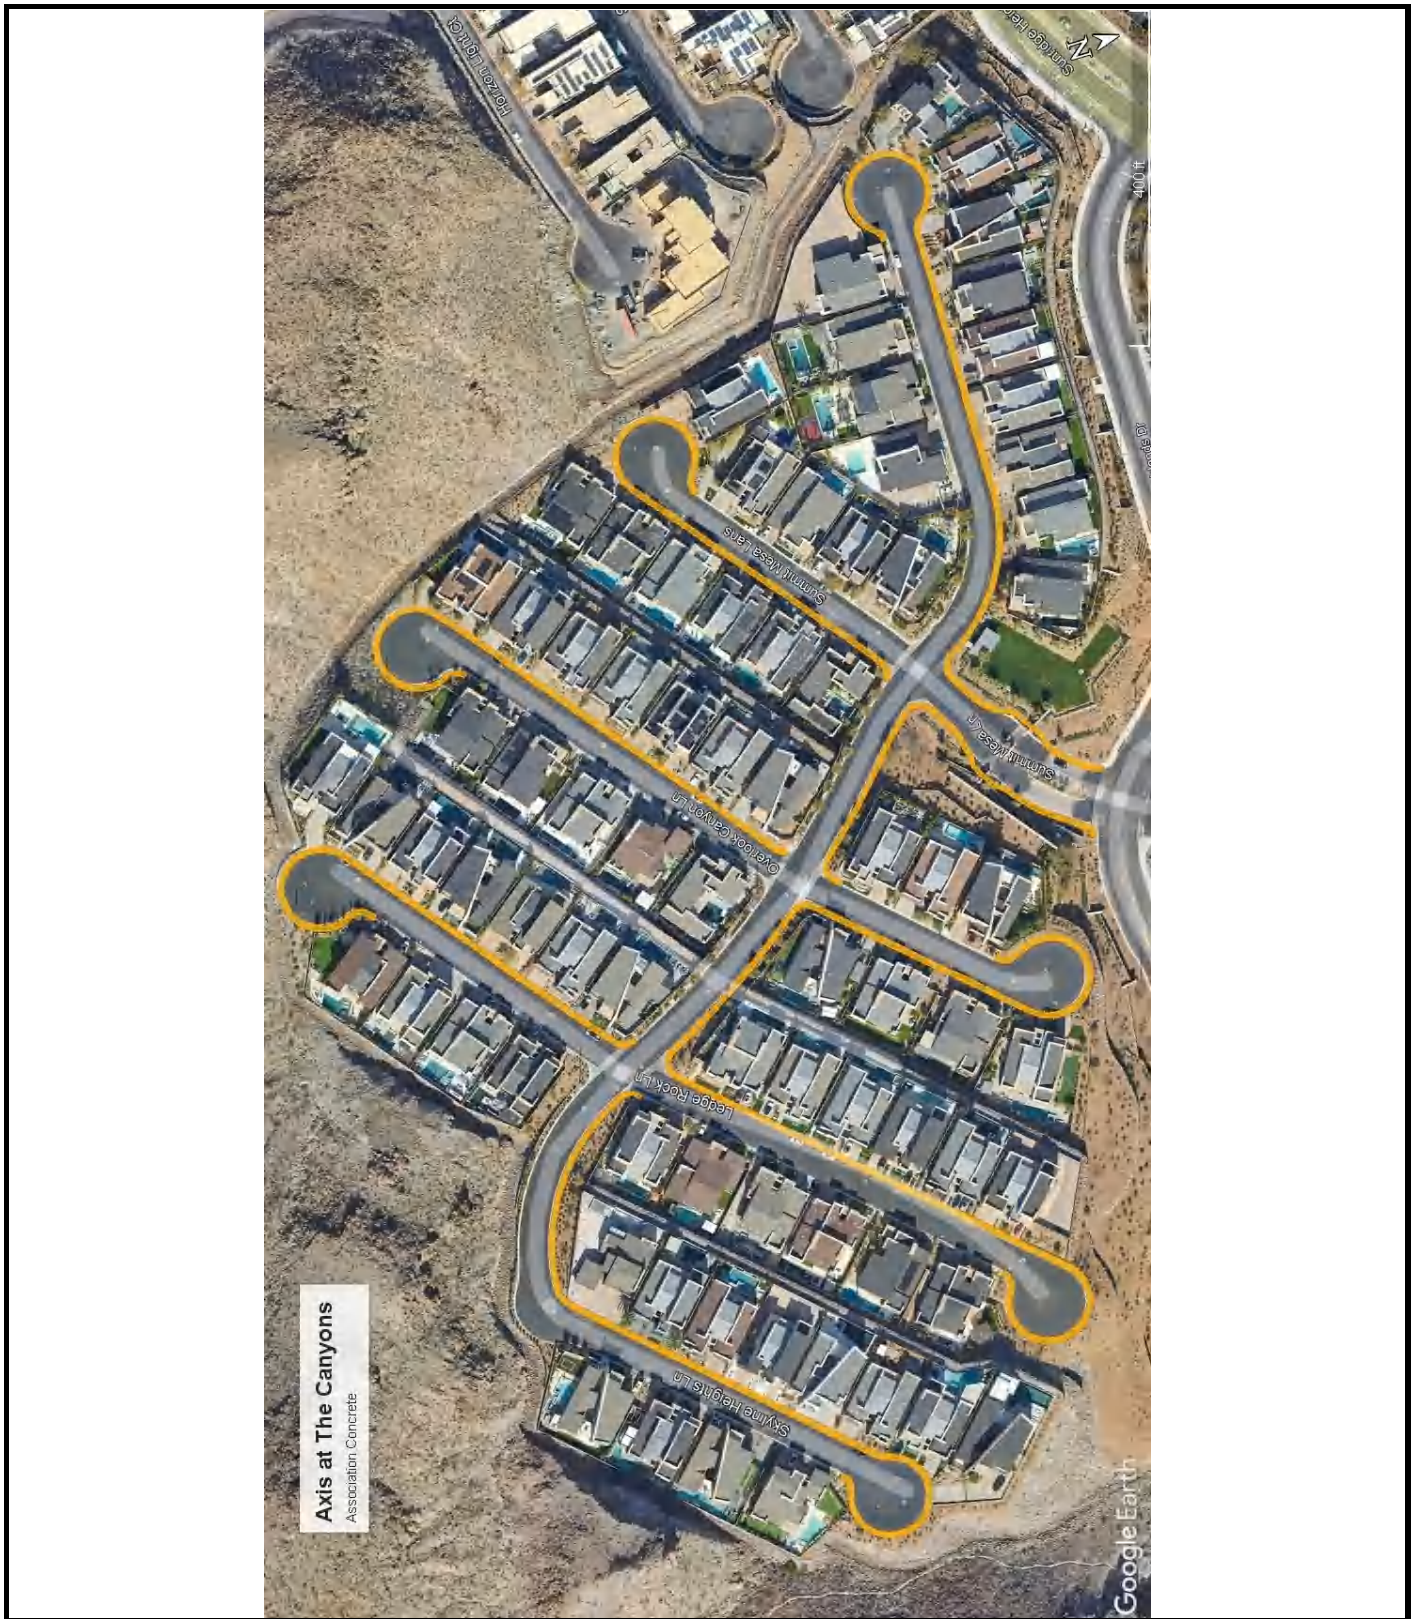
Association maintained concrete

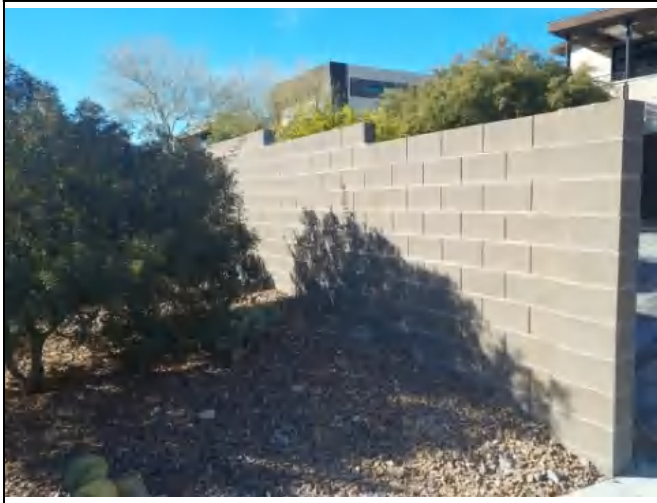
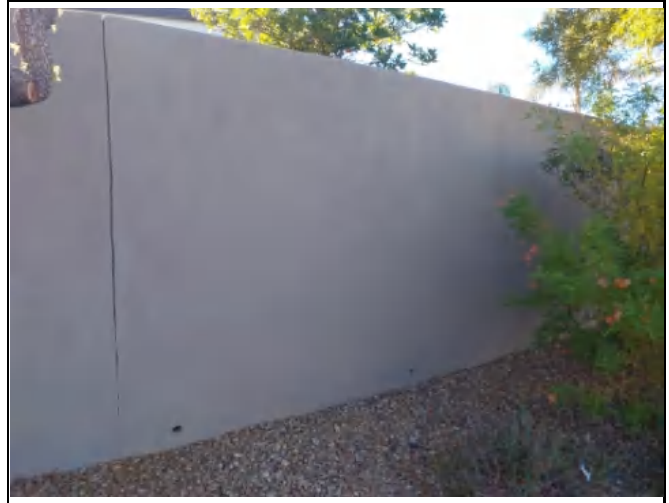
**Comp #: 1.502 Block Wall - Repair**

| <b>Evaluation:</b> | No major issues such as water damage, cracking or other issues noted. | | |
| <b>General Notes:</b> | Note: This measurement represents a linear foot of the wall that is various heights, and located at various elevations. Some of this wall is painted and this measurement includes both painted and non painted areas. This is a general estimate and further inspections are recommended. | | |

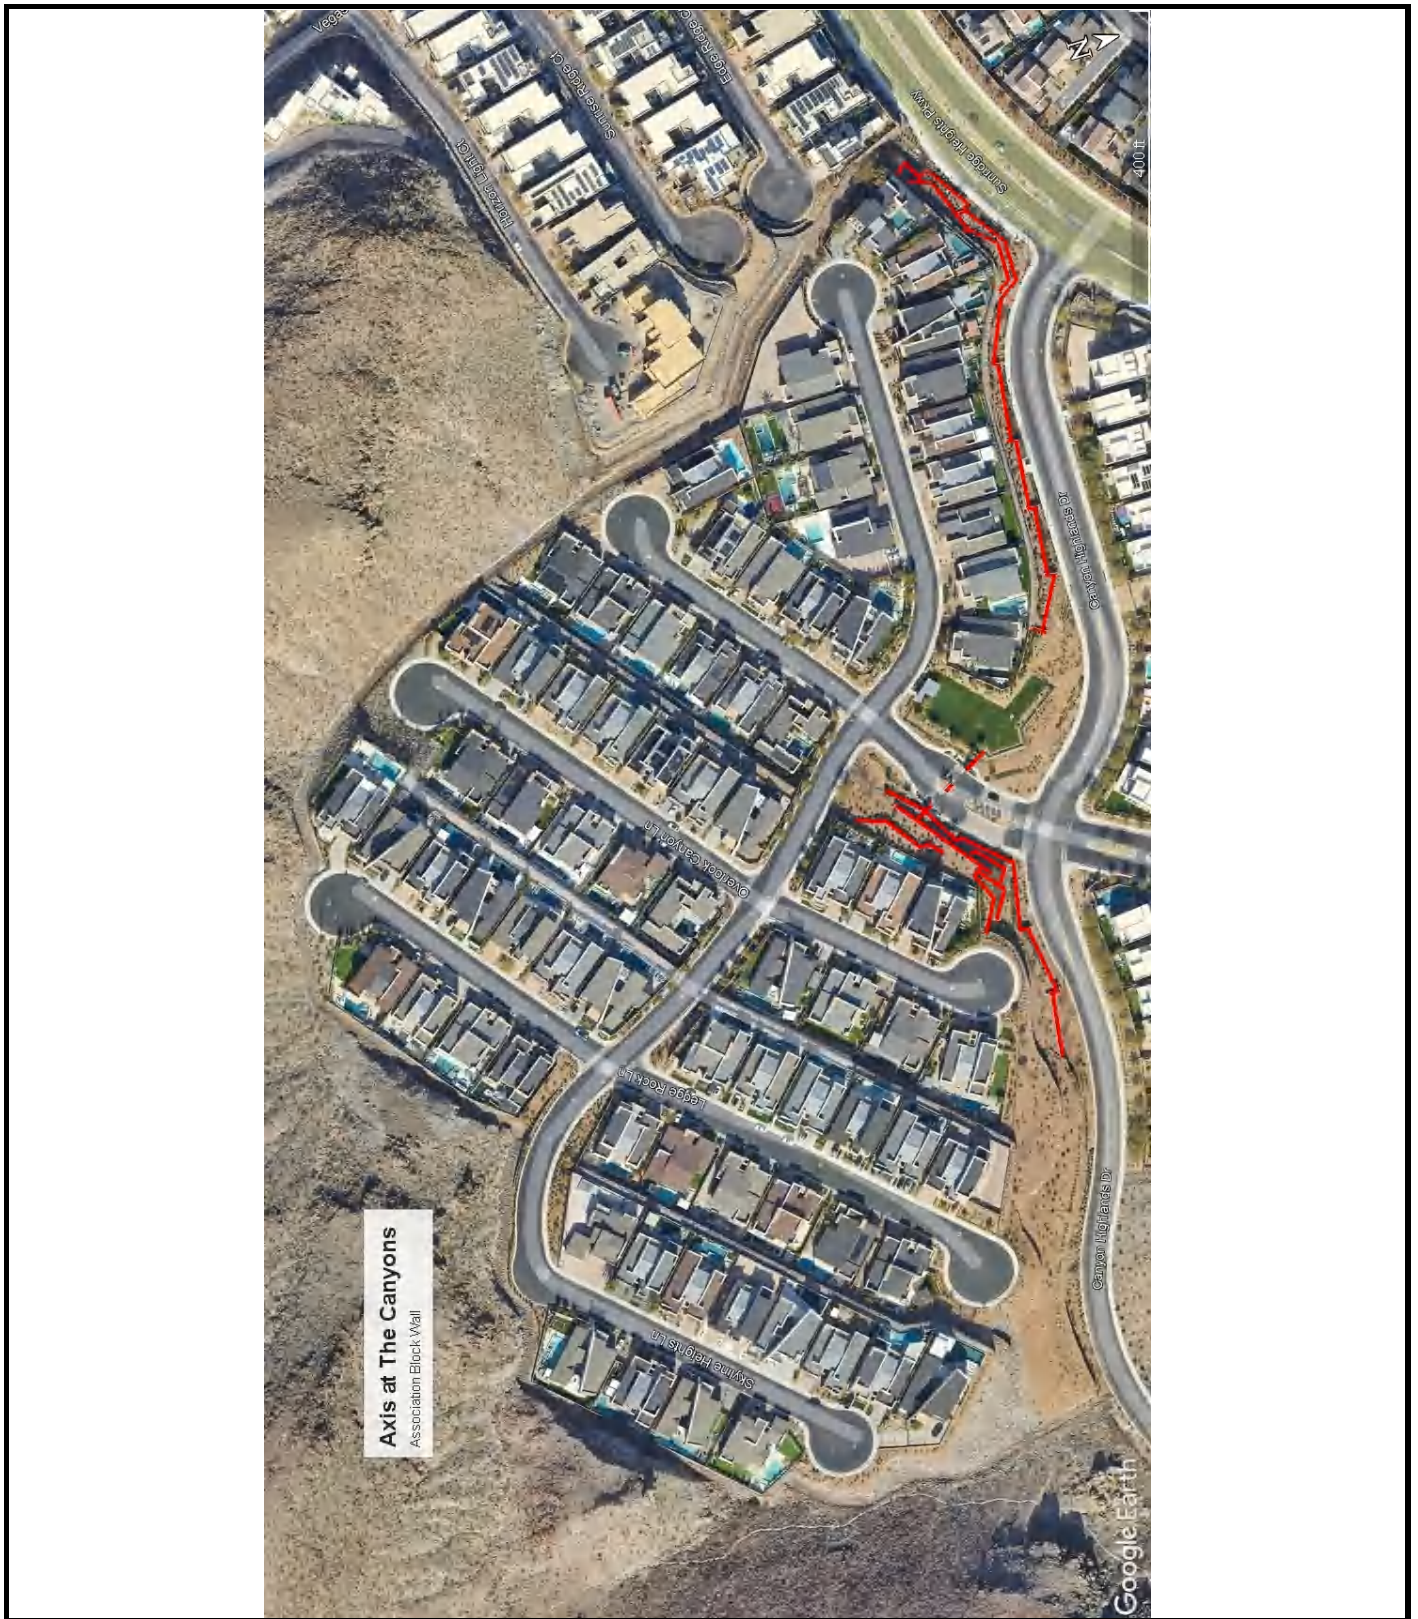
Association maintained block wall

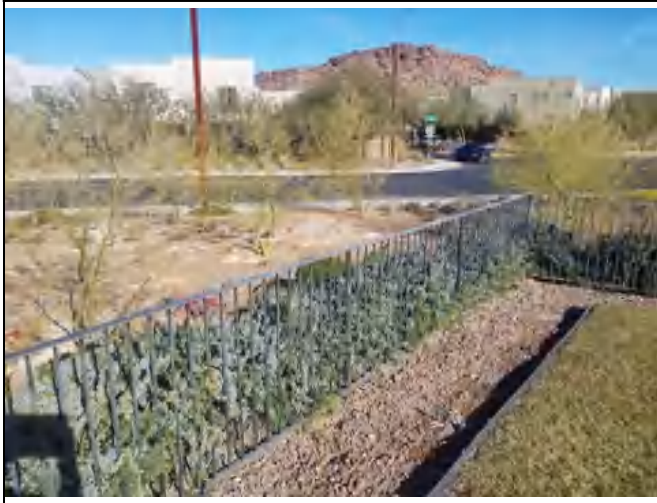
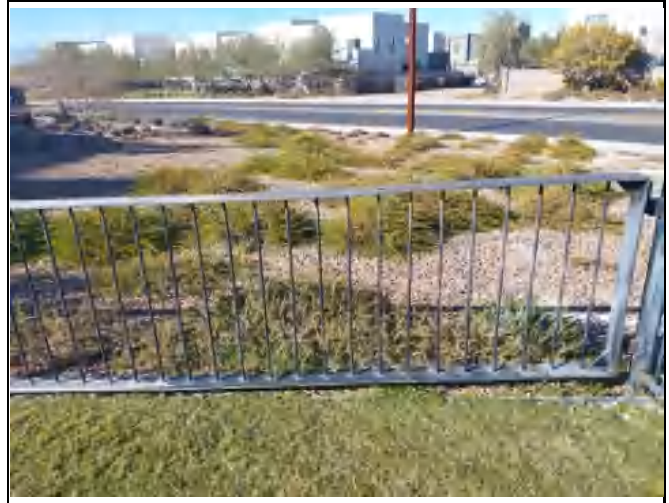
**Comp #: 1.536 Wrought Iron Fencing - Replace**

| <b>Evaluation:</b> | No major rusting, bent areas or other damage noted. | | |

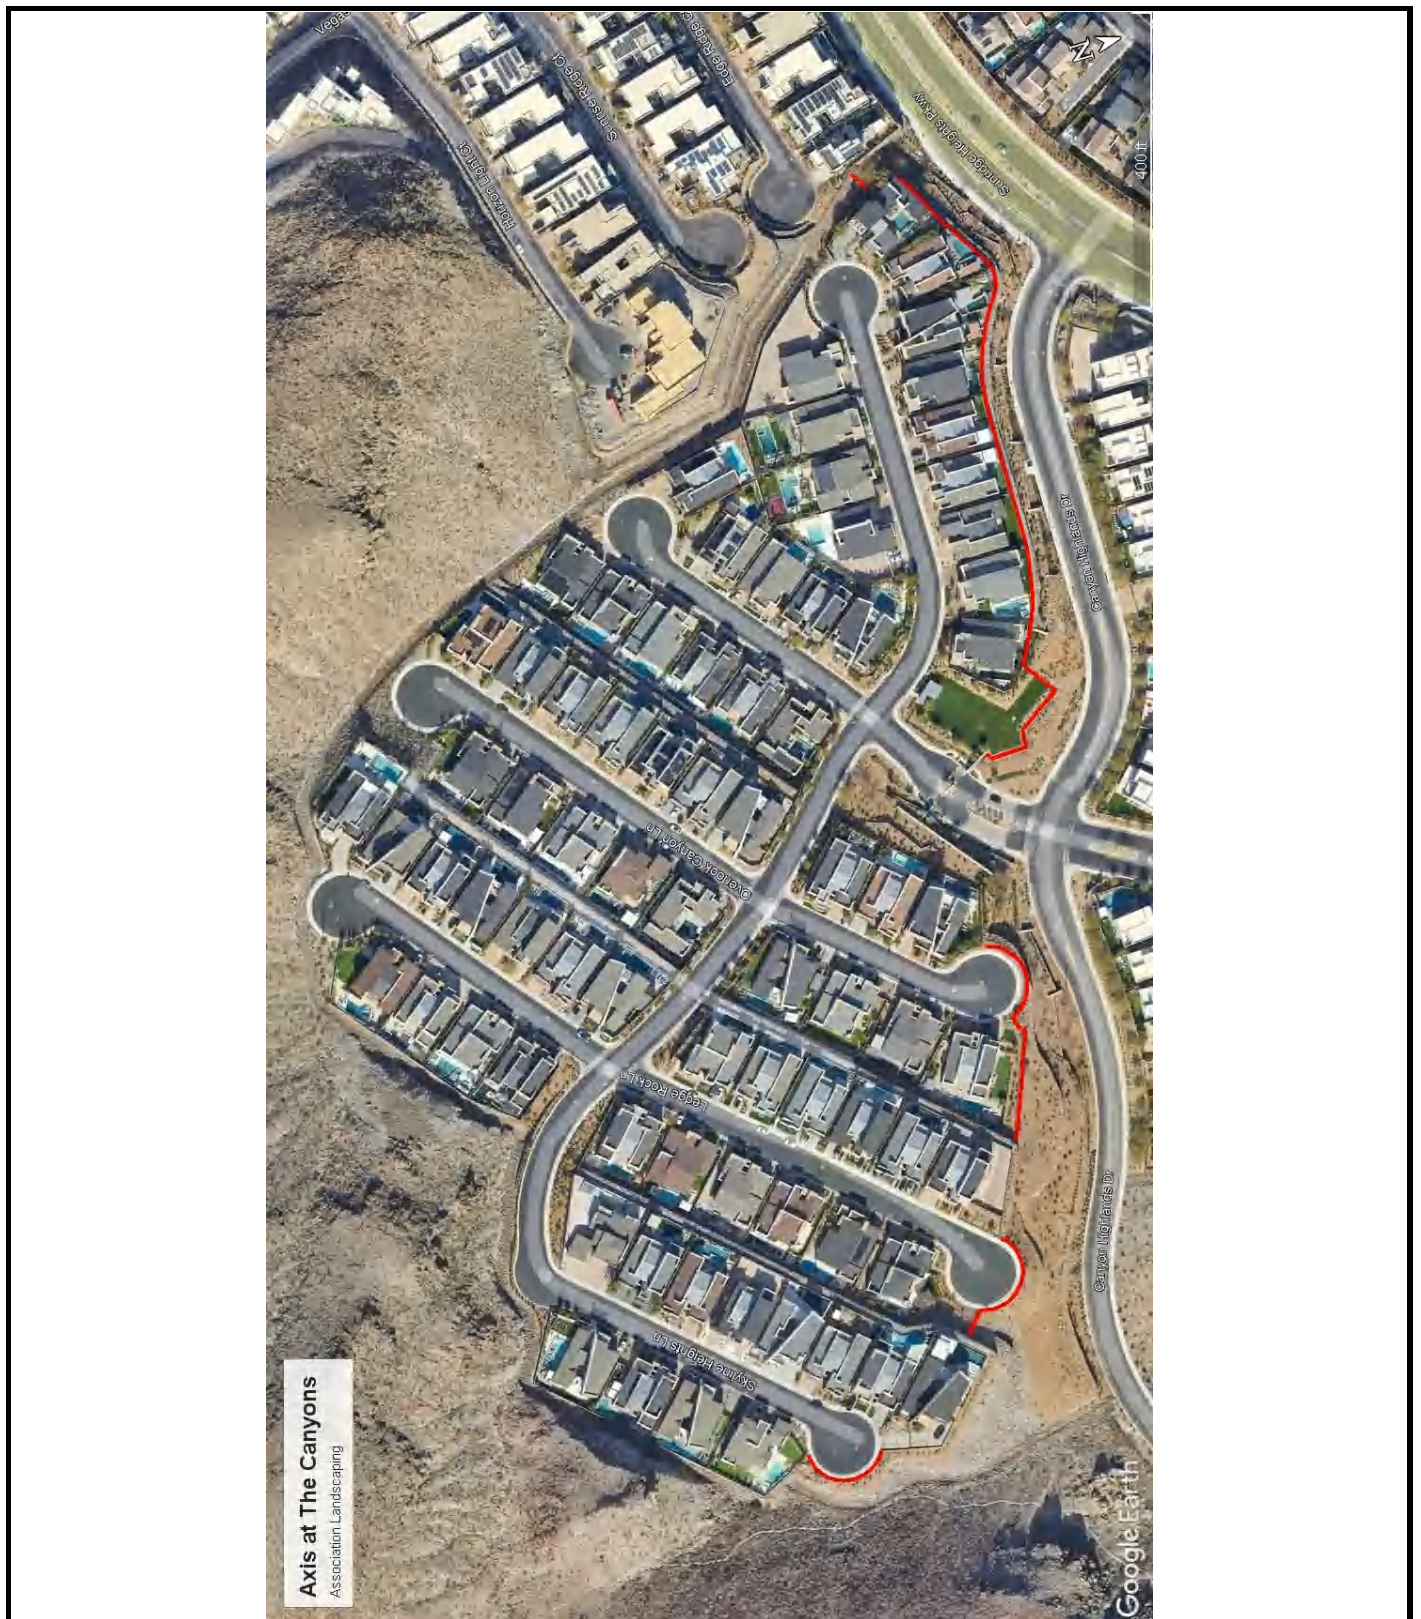
Association maintained metal fencing

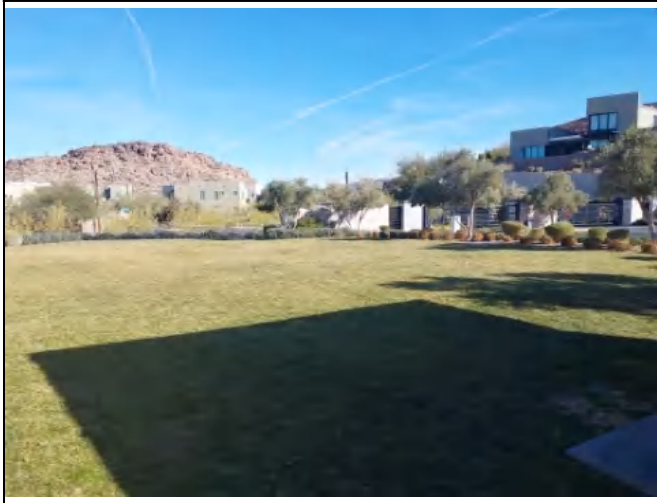
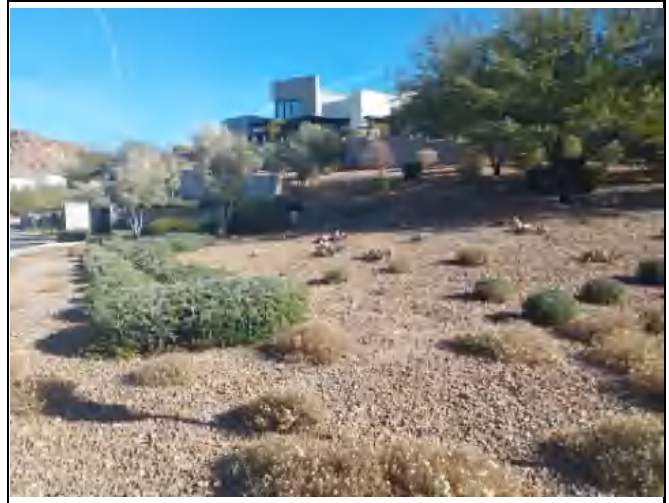
## Comp #: 3.602 Landscaping - Renovate

| <b>General Notes:</b> | This component includes only the maintained sections of the landscaping. | | |

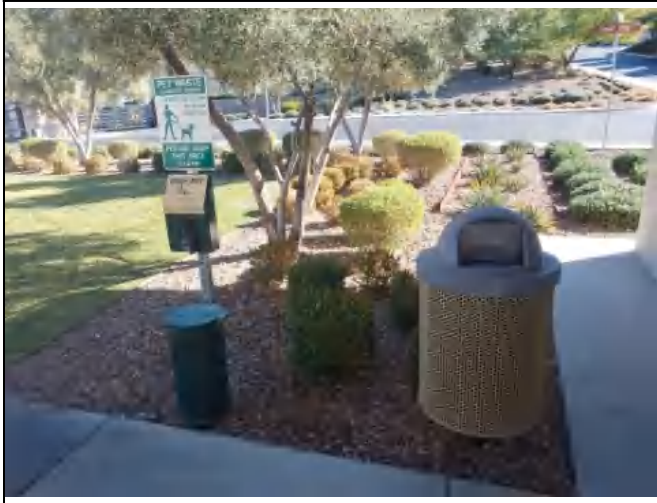
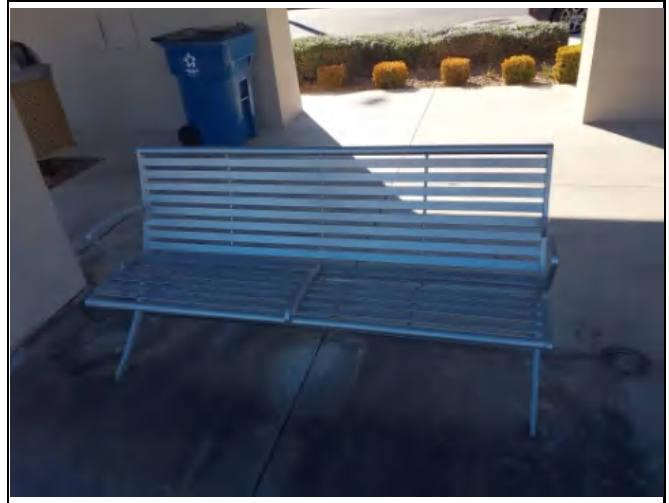
**Comp #: 3.811 Park Furniture - Replace**

| <b>General Notes:</b> | 1 Bench<br>1 Trash Receptacle<br>1 Pet Waste Station | | |
